A1077/B1211 Route Assessment Report – Appendices

April 2021

A1077 Ulceby to Scunthorpe (20/08/2019)

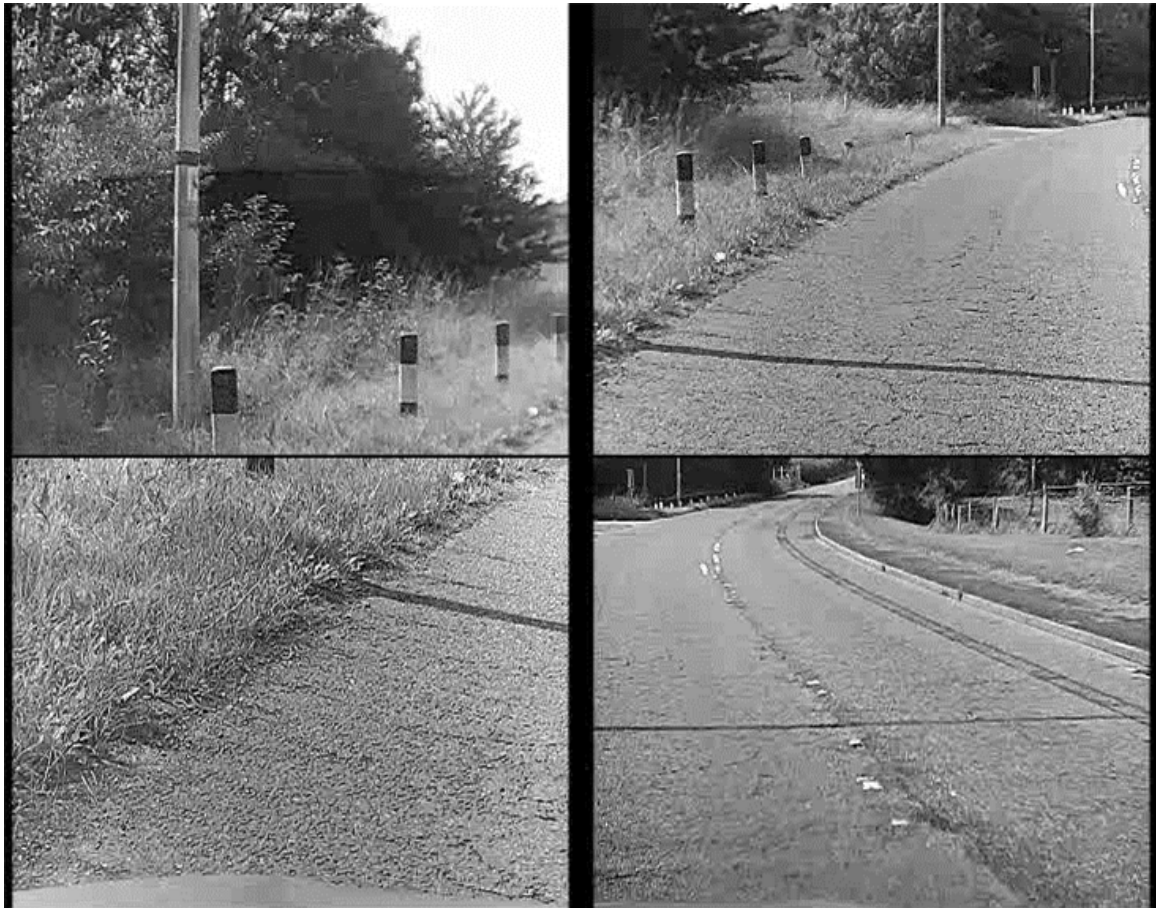
By reviewing video images that accompany the report, we can reference location of observations. Eg, Line 1, frame 4031 refers to issues with a double white line close to Ulceby railway crossing. See images below.

This observation was given the highest severity risk factor of 3. It should also be noted that this section of carriageway has since been subject to a resurfacing scheme.
